**DEPARTMENT OF TRANSPORTATION**

Contract #: 04-0120F4Cty: SF/ALA Rte: 80 PM: 13.2/13.9File #: 69.28**WELDING INSPECTION REPORT****Resident Engineer:** Pursell, Gary**Address:** 333 Burma Road**City:** Oakland, CA 94607**Report No:** WIR-003034**Date Inspected:** 24-Jun-2008**Project Name:** SAS Superstructure**OSM Arrival Time:** 630**Prime Contractor:** American Bridge/Fluor Enterprises, a JV**OSM Departure Time:** 1530**Contractor:** Zhenhua Port Machinery Company, Ltd (ZPMC), Changxing Island **Location:** Shanghai, China

## WELDING INSPECTION REPORT

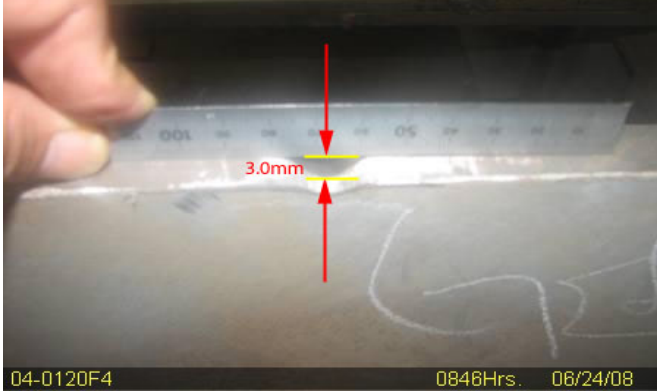
This QA observed ZPMC MT personnel Wang Wei perform 10% Magnetic Particle Testing on fillet weld between stiffener and flange to web plate of floor beam FB001-005 and FB016-011. It was noted that rust and scale have been removed by ZPMC workers on weld areas prior MT testing. Electromagnetic Yoke was used with alternating current (AC) as power source. The detection media used was dry red ferromagnetic particles and applied with powder blower while the magnetizing force is on and magnetizing force is applied in perpendicular direction (180 degree apart). On this test, two transverse cracks were found on fillet weld of floor beam FB001-005 and five transverse cracks were found on fillet weld of floor beam FB016-011. Aside from transverse cracks that ZPMC/NDE found, this QA noted fillet weld cold lap on floor beam FB016-011 weld joints 015/016 and 017/018, 3 notches on each of the floor beam flanges that were not properly blended into 10:1 ratio and noted Hi/Lo between the stiffener plate and flange. On this flange/stiffener intersection, ZPMC has blended some of it and left some as it is. See photo below.

Bay 7: Floor Beam FB016-011 flange having notch not properly blended into 10:1 ratio.

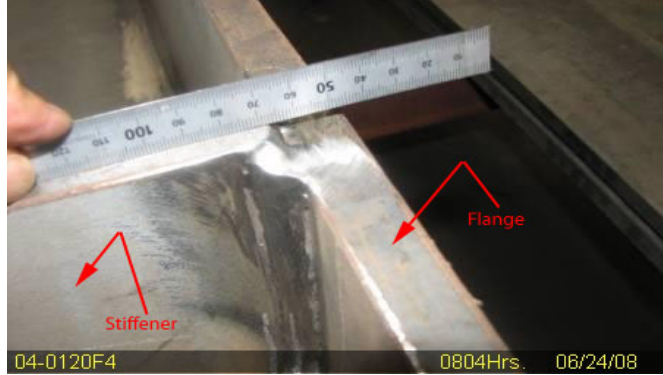
Bay 7: Floor Beams FB001-005 and FB016-011 having Hi/Lo on stiffener to flange connection. ZPMC is unaware of what to do on this because some of these they just let it as it is and some they tried to blend.
